Inspection Report for flood Damage Work

1. Name of PIU :- Sri. Jaimangal Rabidas, (R.W.D. Works Division, Banka-1)
2. Name of Block/ Road :- Fullidumar / L068 Samukhiya More to Kadbara (Track 68)

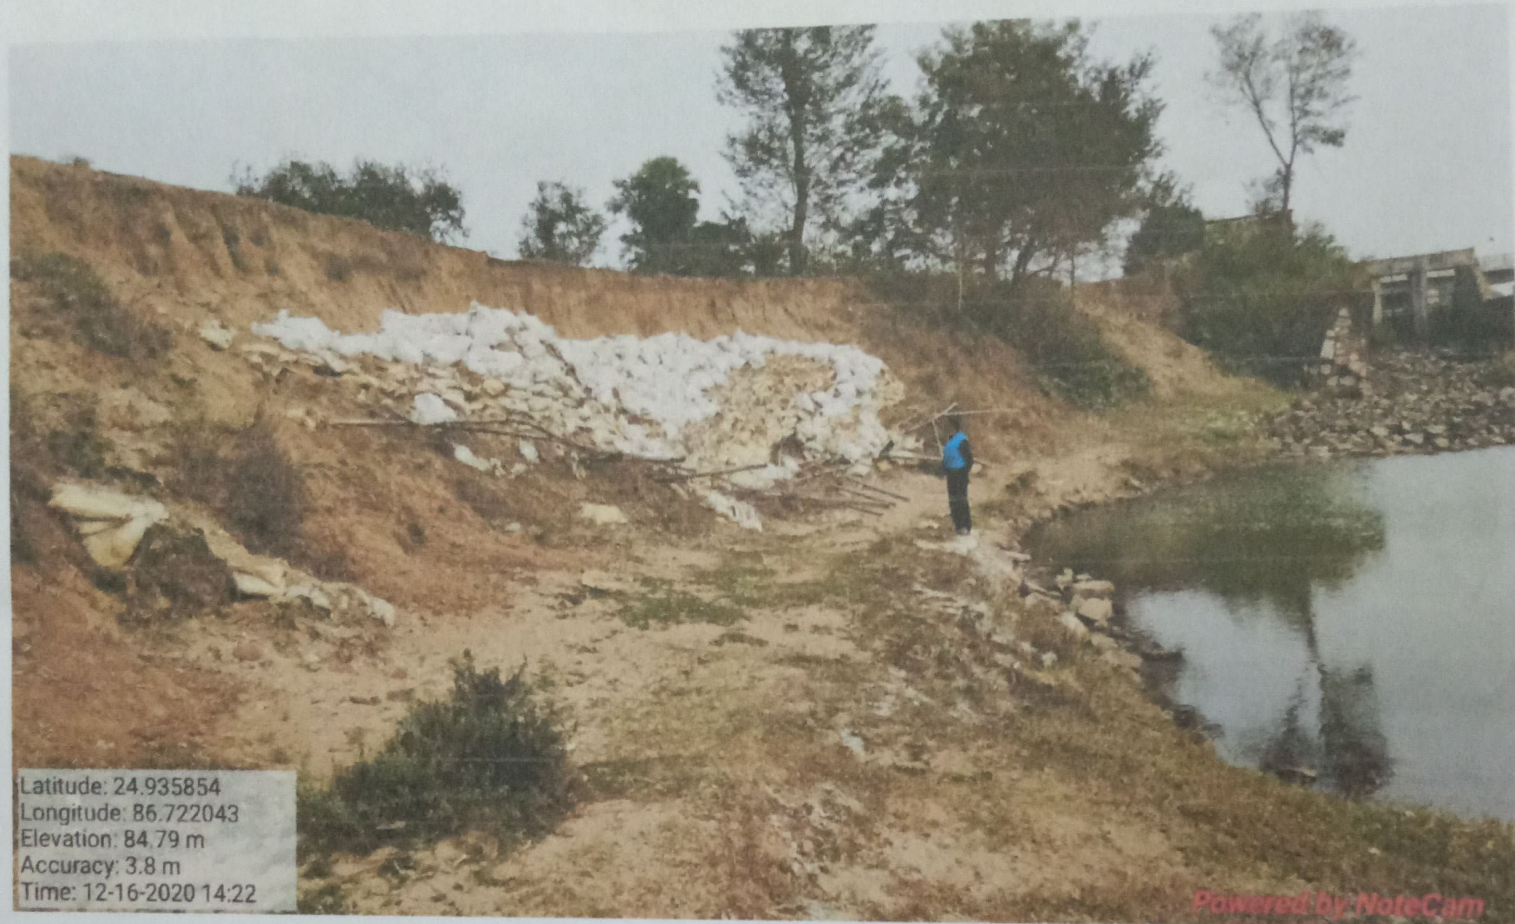
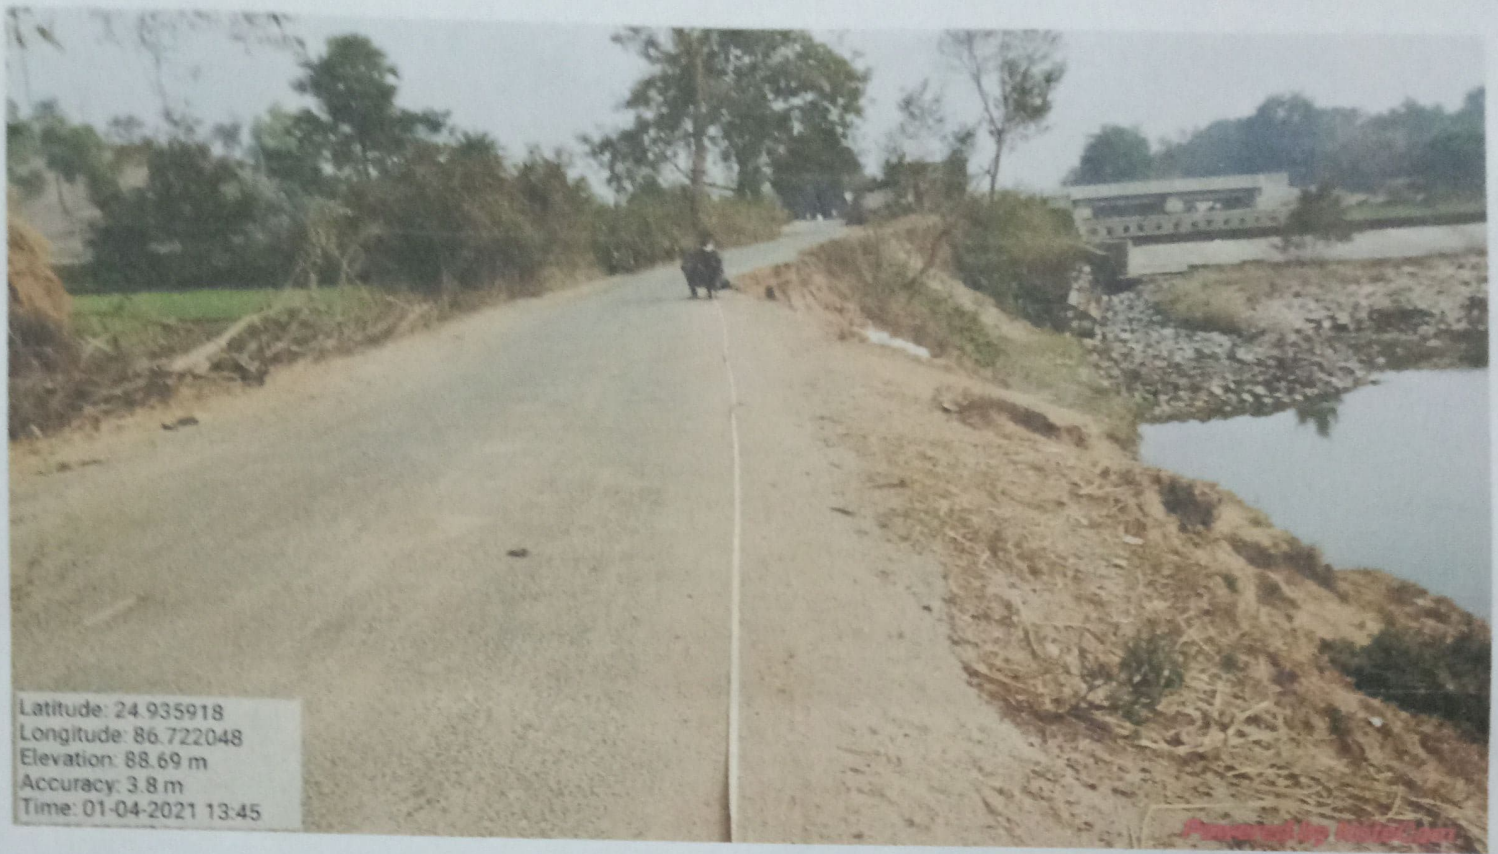
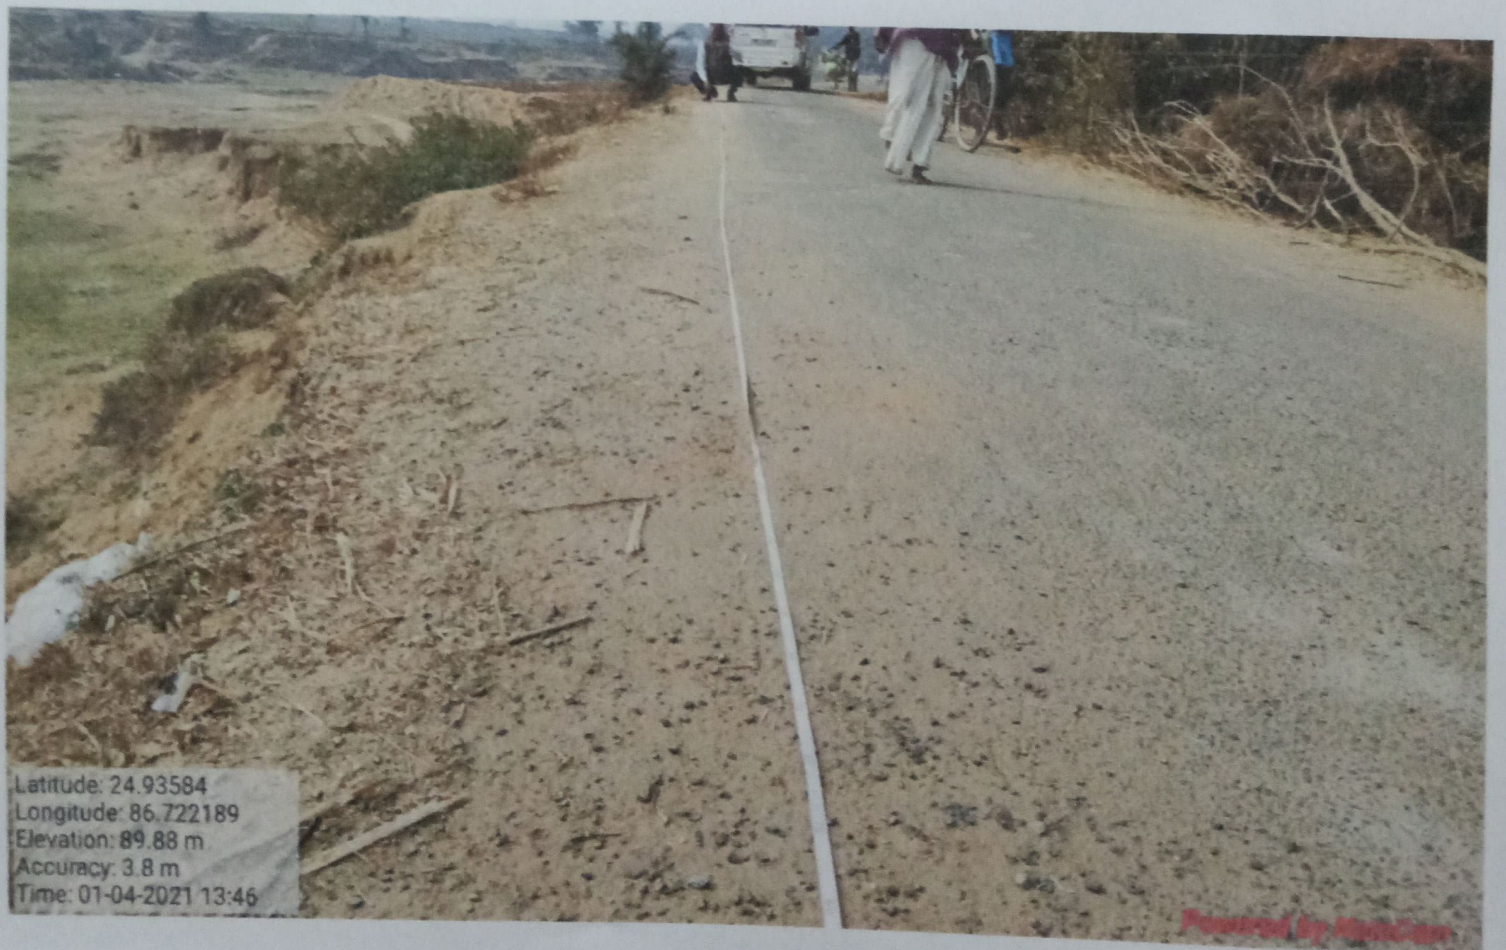
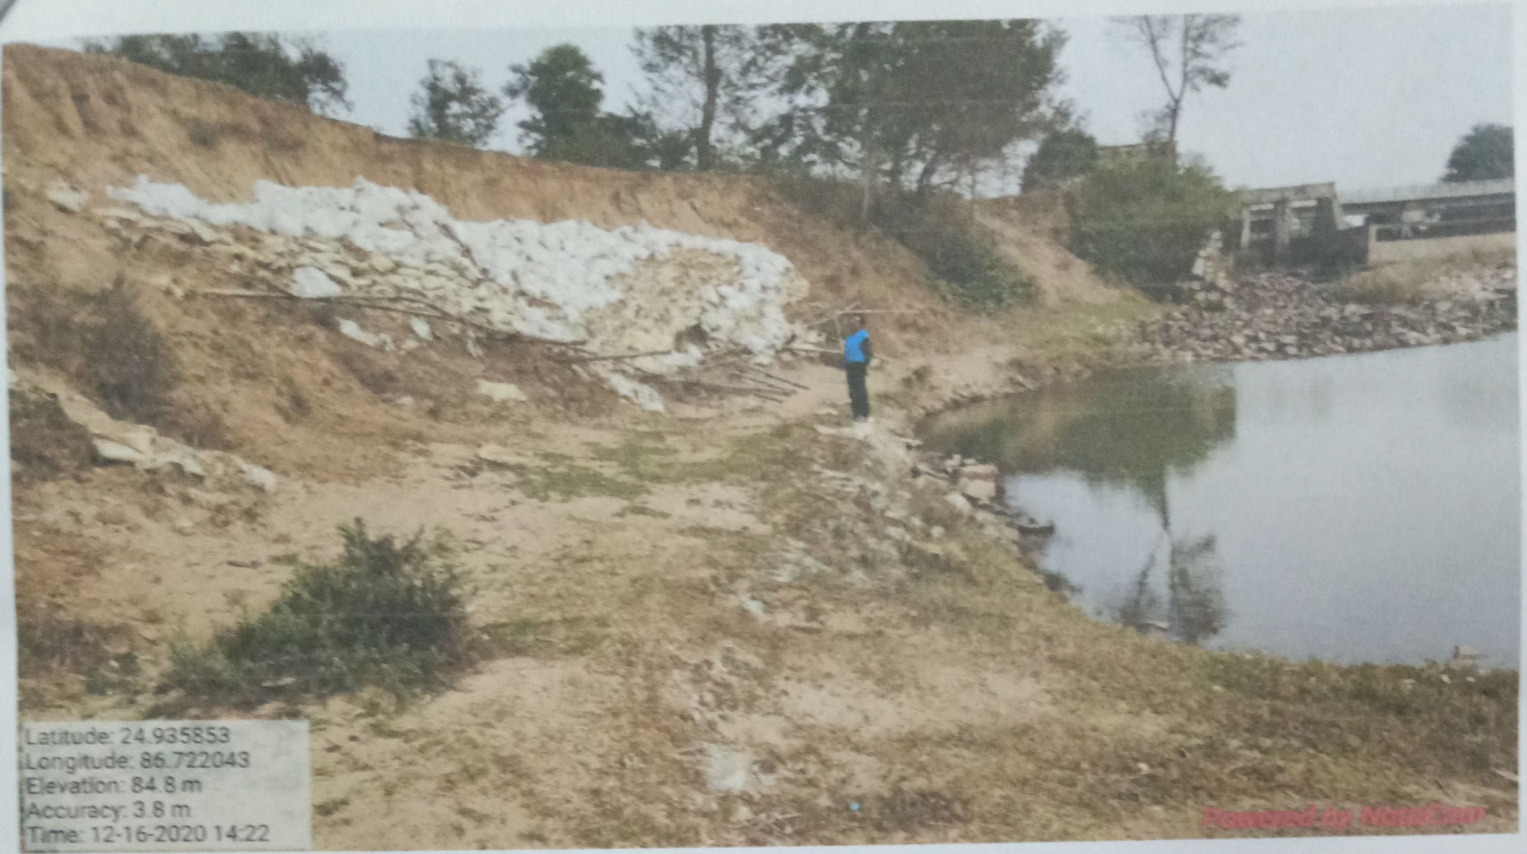
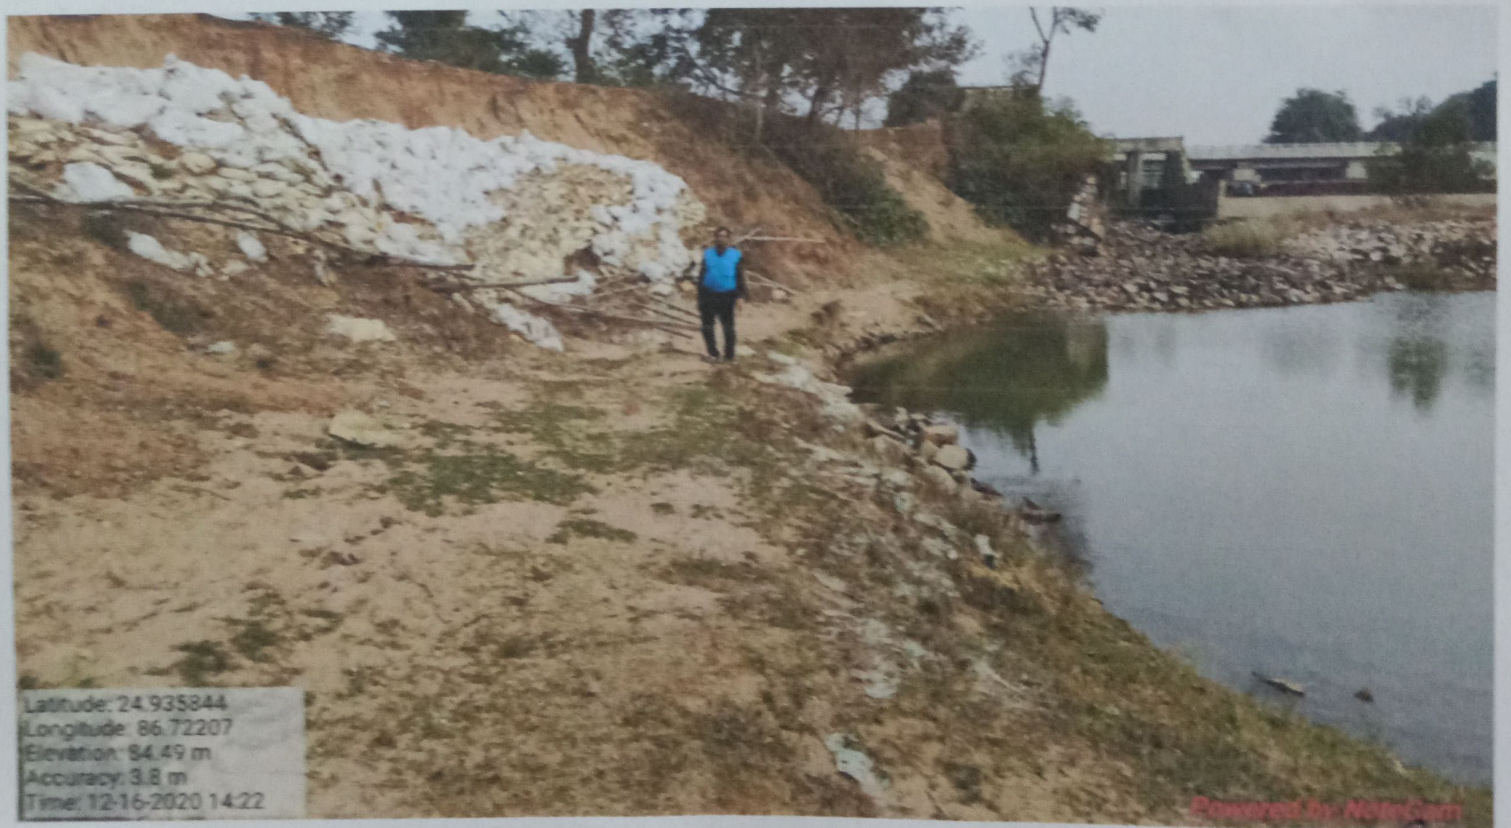
1. Damage Location / Chainage :- 0.102 Km to 0.160 Km
2. Damage Length :- 0.058 Km
3. Nature of Damage :- Shoulder & Road Crust has been damaged.
4. Details of Restoration Works
i. Material being used in Restoration works :- Brick bat , moorum and bamboo
ii. Equipments/ Tools being used in Restoration works :- JCB, Tractor
iii. Procedure taken up in Restoration works :-
iv. Restored Length :- 0.058 KM
