PDF Compressor Free Version
Inspection Report For Flood Damage Work
1 Name of Dille: R. W. D. Grabalgarij-2 0 to Dhoron Goli Hote
1. Name of PIUs: R.w.D Gapalgarij-2  2. Name of Block/Road: Baranli/Bishumburg Path be Dhorn Goli Hote  Hue Gurana Goli Gak.
A For Road

## FLOOD DAMAGED REPAIR (F.D.R.)

Bisunpura Path Se Dhom Toli Hote Hue Turaha Toli Tak

EXECUTIVE ENGINEER RWD (W) DIVISION GOPALGANJ-2

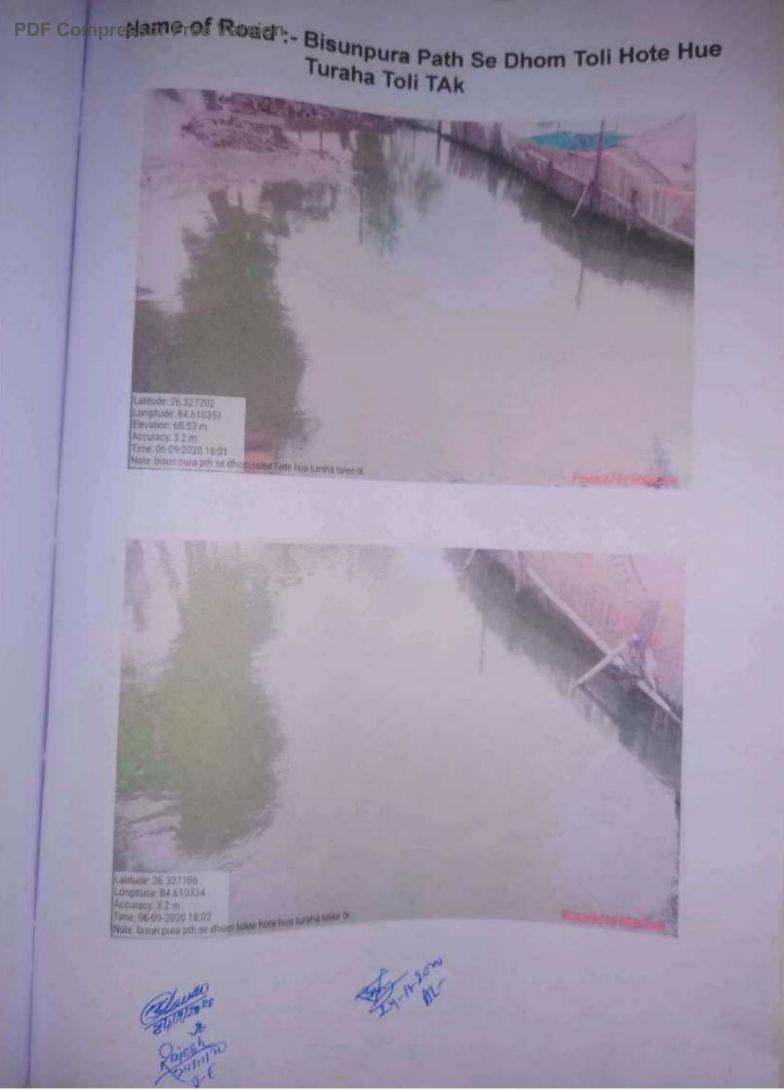
## PDINAMINETON ROAD : Version Bisunpura Path Se Dhom Toli Hote Hue Turaha Toli TAk Latitude 26 327228 Longitude: B4 610542 Elevation 65.56.m. Accuracy 3.2 in Time 06-09-2020 18:03 Note tissus pura pth se show toke hore has turning thing to Lectude: 26,228121 Langitude: 84-6178-56 Accuracy 3.2 m Time 06-09-2020 18:07 Note: tillium puru gith se di
