Rural Works Department, Govt of Bihar

## FLOOD DAMAGED REPORT

### Baniyapur Se Pirauta Khas Sadak ke Gandki Nadi ke Katav ka Suraksha kary

# Inspection Report for Flood Damage

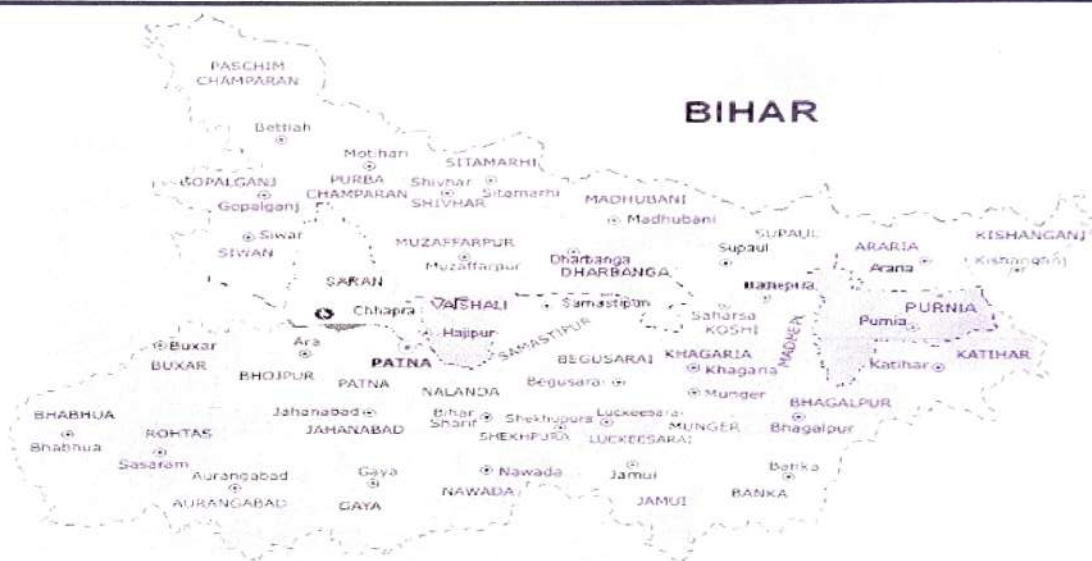
1. Damage Location/Chainage :- *8th Km*
2. Damage Length :- *0.164 Km*
3. Nature of Damage :- *Shoulder, road embankment cutting surrounding of Ghatki etc*
4. Details of Restoration :- *Bambo pilling, Sand bag (mud), Chacha Bambo hammers.*
  - i. Material being used in restoration :- *Bambo, Bambo hammers*
  - ii. Equipment/Tools being used in restoration works :-
  - iii. Procedure taken up in restoration works :- *Manual labour,*
  - iv. Restored length :- *0.164 Km*
