**Rural Works Department, Govt of Bihar**

**2021-22**

# FLOOD DAMAGED REPORT

# Repair of Road MDR to Harshankarpur

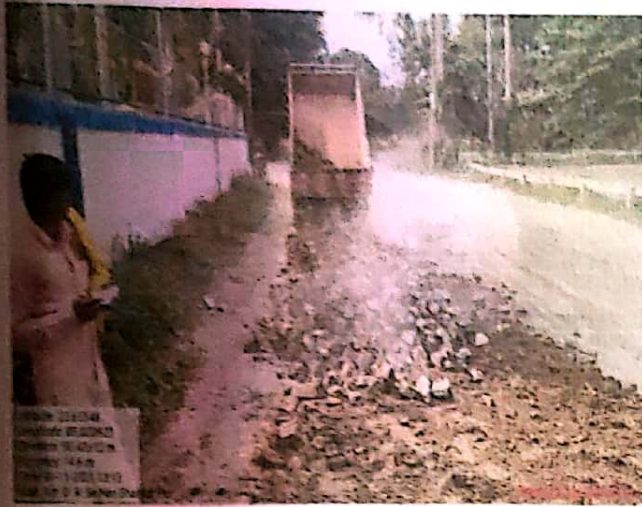
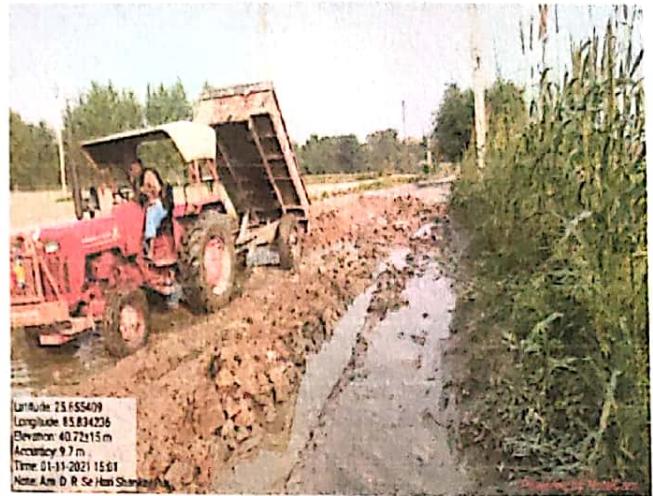
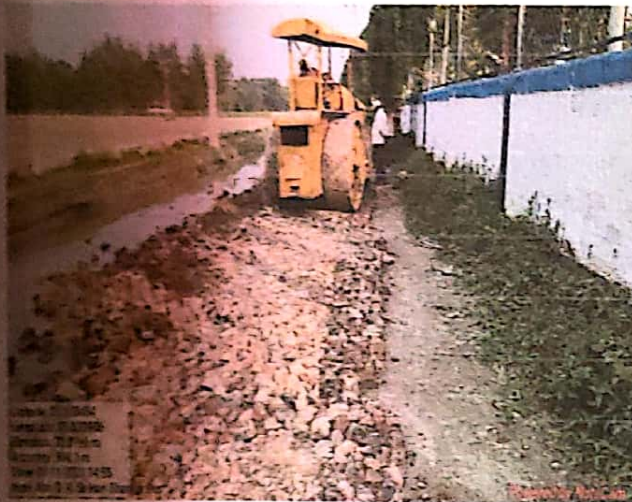
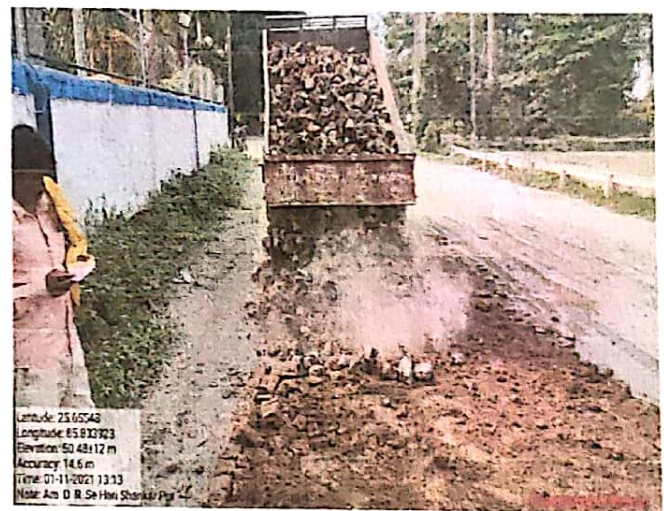
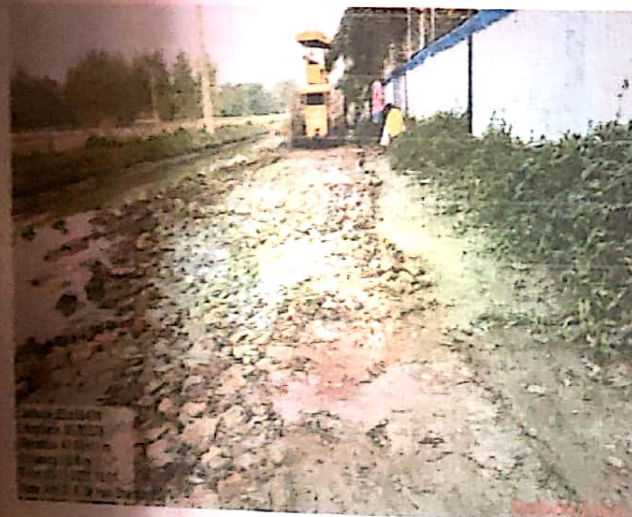
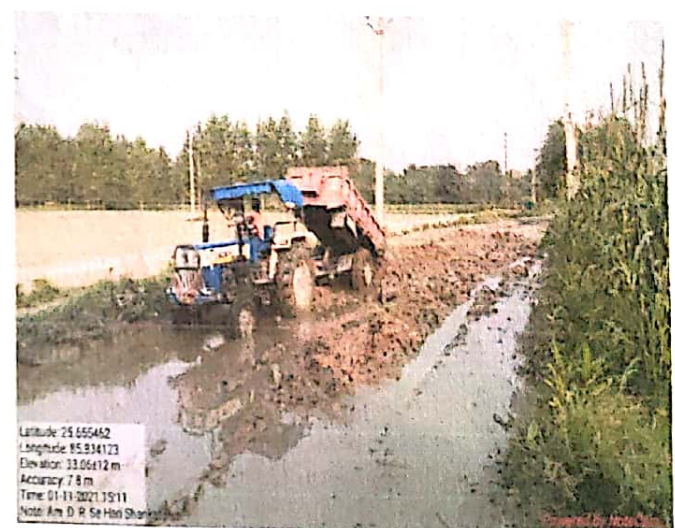
# Site Photograph

me of Road:-MDR to Harishakarpur

Block-dalsinghsarai

3. Nature of Damage : Due to heavy rain

4. Details of Restoration Works : Brick Bat
