# ग्रामीण कार्य विभाग

## FLOOD DAMAGED REPORT

### T04 to Yadav Tola

# Inspection Report for Flood Damage Work

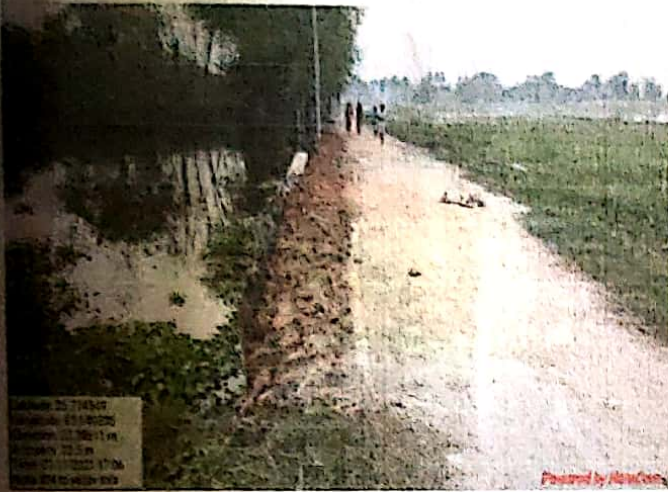
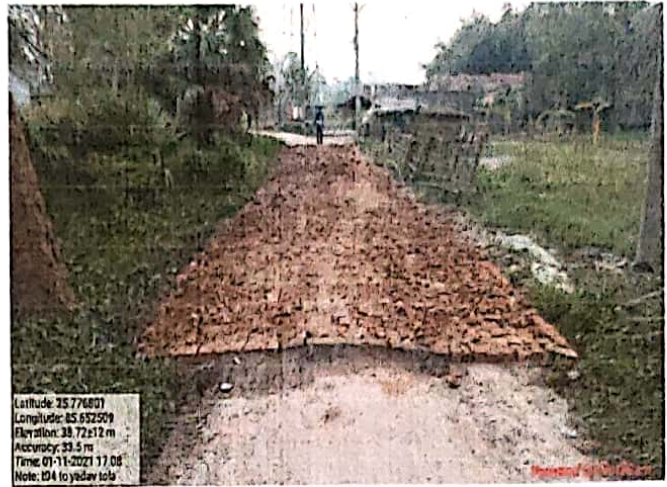
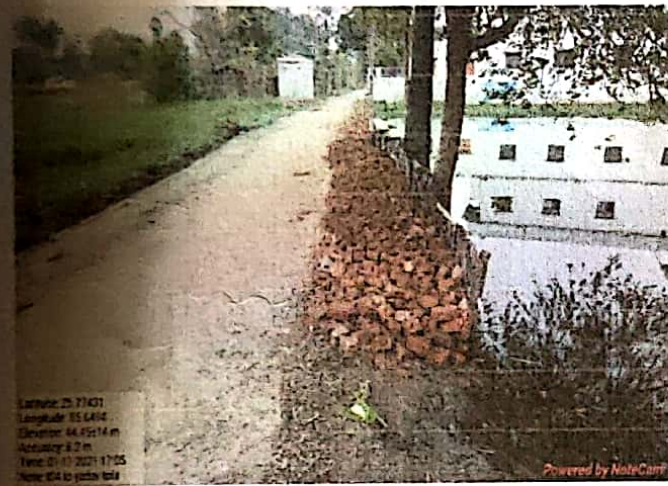
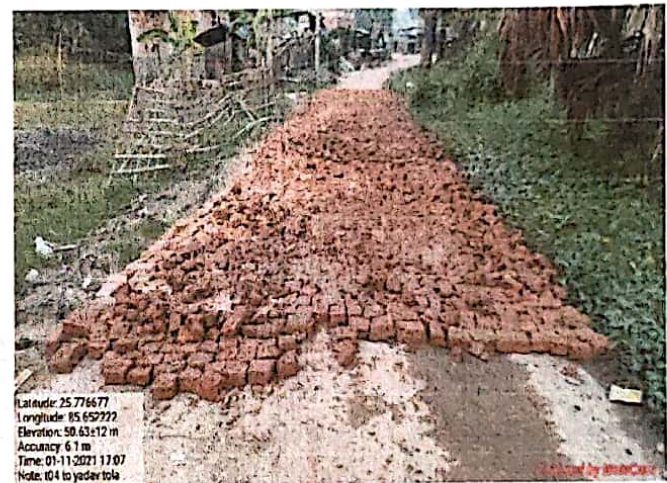
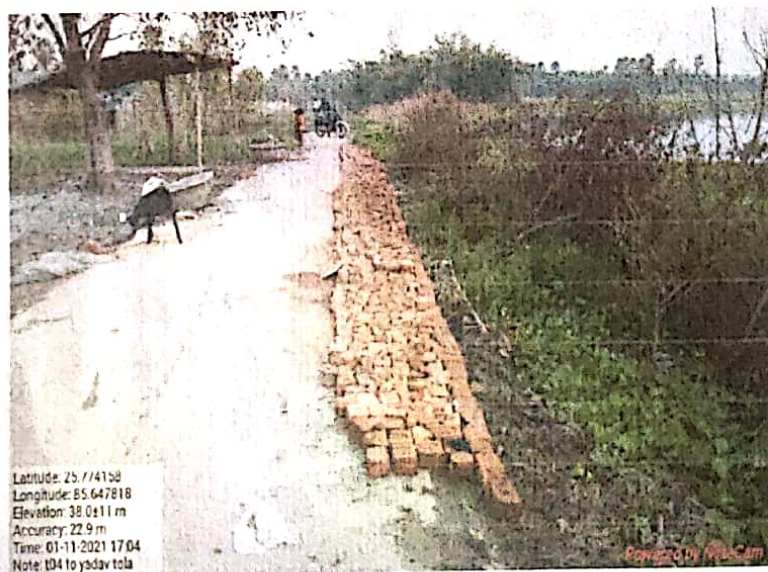
# Site Photograph

1. Damage Location/Chainage : 30m to 60m & 400m to 472m

2. Damage Length : 102m

3. Nature of Damage : Flood

i. Material being used in Restoration works : Bamboo, Brick bats ~~& Cement~~

iii. Procedure taken up in Restoration works : Bamboo piling with chachari and filling Brick bats.
