Rural Works Department, Govt of Bihar

## FLOOD DAMAGED REPORT

## L043 to Keari

Location of Road:- L043 to Keri  
 k- Bibhutipur

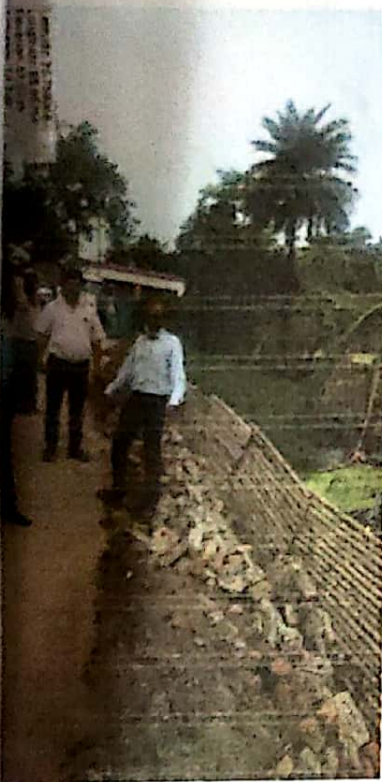
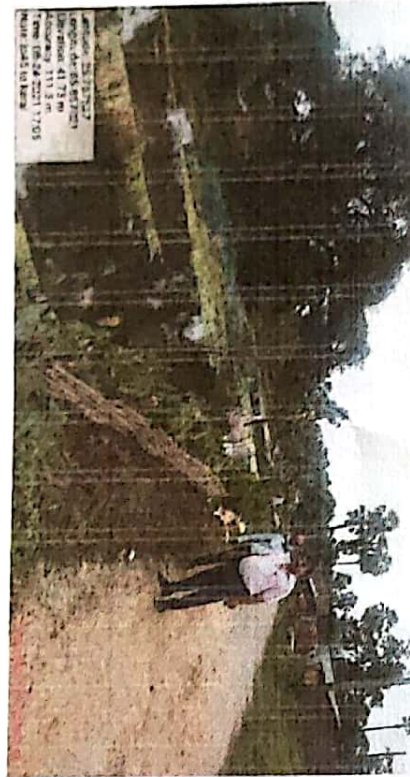
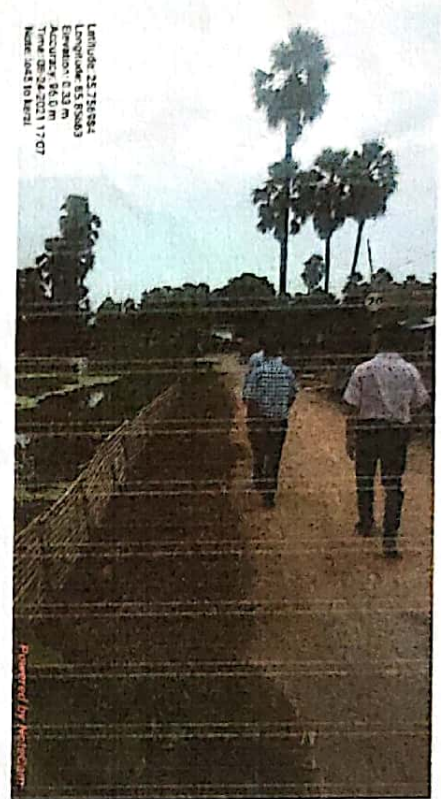
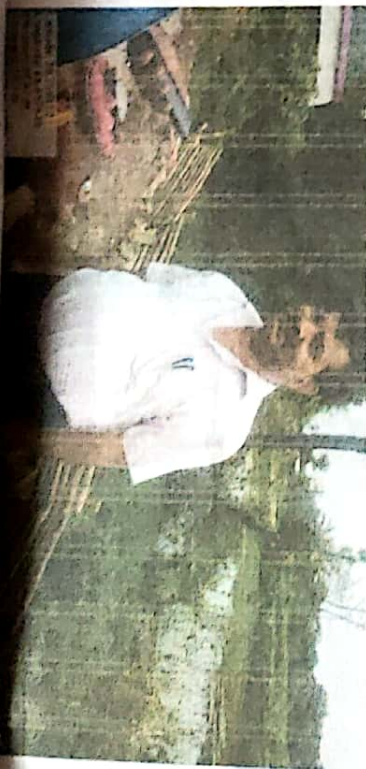
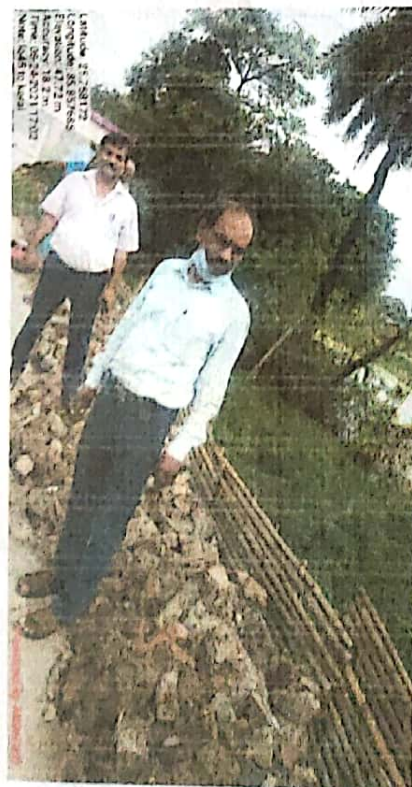
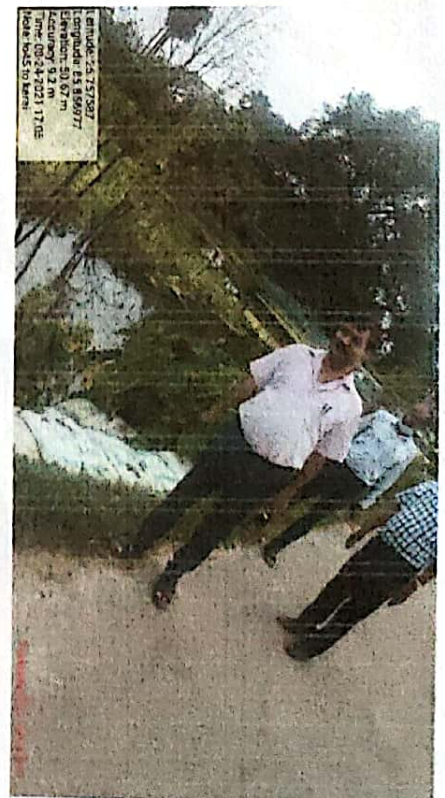
# Site Photograph

1. Damage Location/Chainage : 2.20 km – 2.405 km

2. Damage Length : 0.205 km

3. Nature of Damage : flood

i. Material being used in Restoration works : Bamboo piling, Brick bats

iv. Restored Length : 0.205 km
