INSPECTION REPORT FOR MOTORABLE WORK

Name of PIUs: - Anish kr. Singh (Exewtive Engineer) Name of Block/Road: - Asthonom	
Name of Block/Road:- Asthowan	
A. For Road	
1. Damage Location/Chainage:- 2.8 km

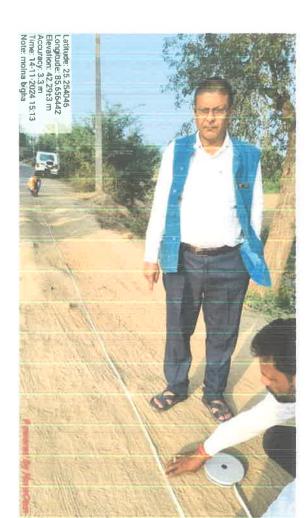
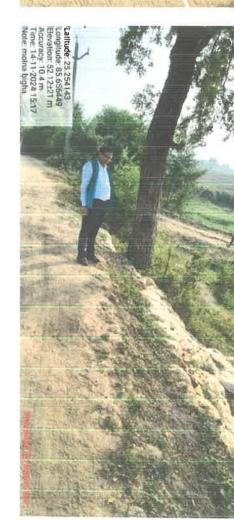
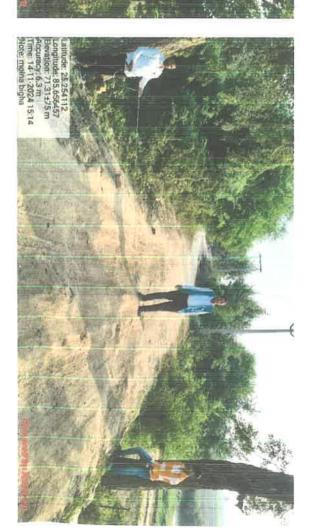
Latitude: 25.254175
Longwide: 85.656471
Elevation: 43.8243 m
Accuracy: 3.0 m.
Time: 14-11-2074 15-12
Note: molina bigita

2. Damage Length:- 13 M W	
3. Nature of Damage (Length Wise) (i) Breach :- 12 \(\text{ii)} \) Crust Damage :- 14 \(\text{m} \) (iii) Only Flank Damage :- 19 \(\text{m} \)	
whether traffic fully/Partialiy obstructed:-	,

4. Details of Restoration:-	
(i) Material Being Used in Restoration: Bricks bats, Sond bag.	2
(ii) Equipment/Tools Being Used in Restoration Works: - Trader, Hipper	ומצי
(iii) Restored Length In open Area:- 15 m	
In habitation Area:- NA	
(iv) If Restoration work done in habitation Area give Reason:- NA
