Estimate for Repair of Road breaches (Damaged by Flood) for Motoribility in Nimai Chowk To Parsa Dhangahtola Sanichari

TECHNICAL REPORT

INSPECTION REPORT FOR MOTORABLE WORK

ESTIMATE FOR REPAIR OF ROAD BREACHES (DAMAGED BY FLOOD) FOR MOTORIBILITY IN NIMAL CHOWK TO PARSA DHANGAL TOLA SANICHARI

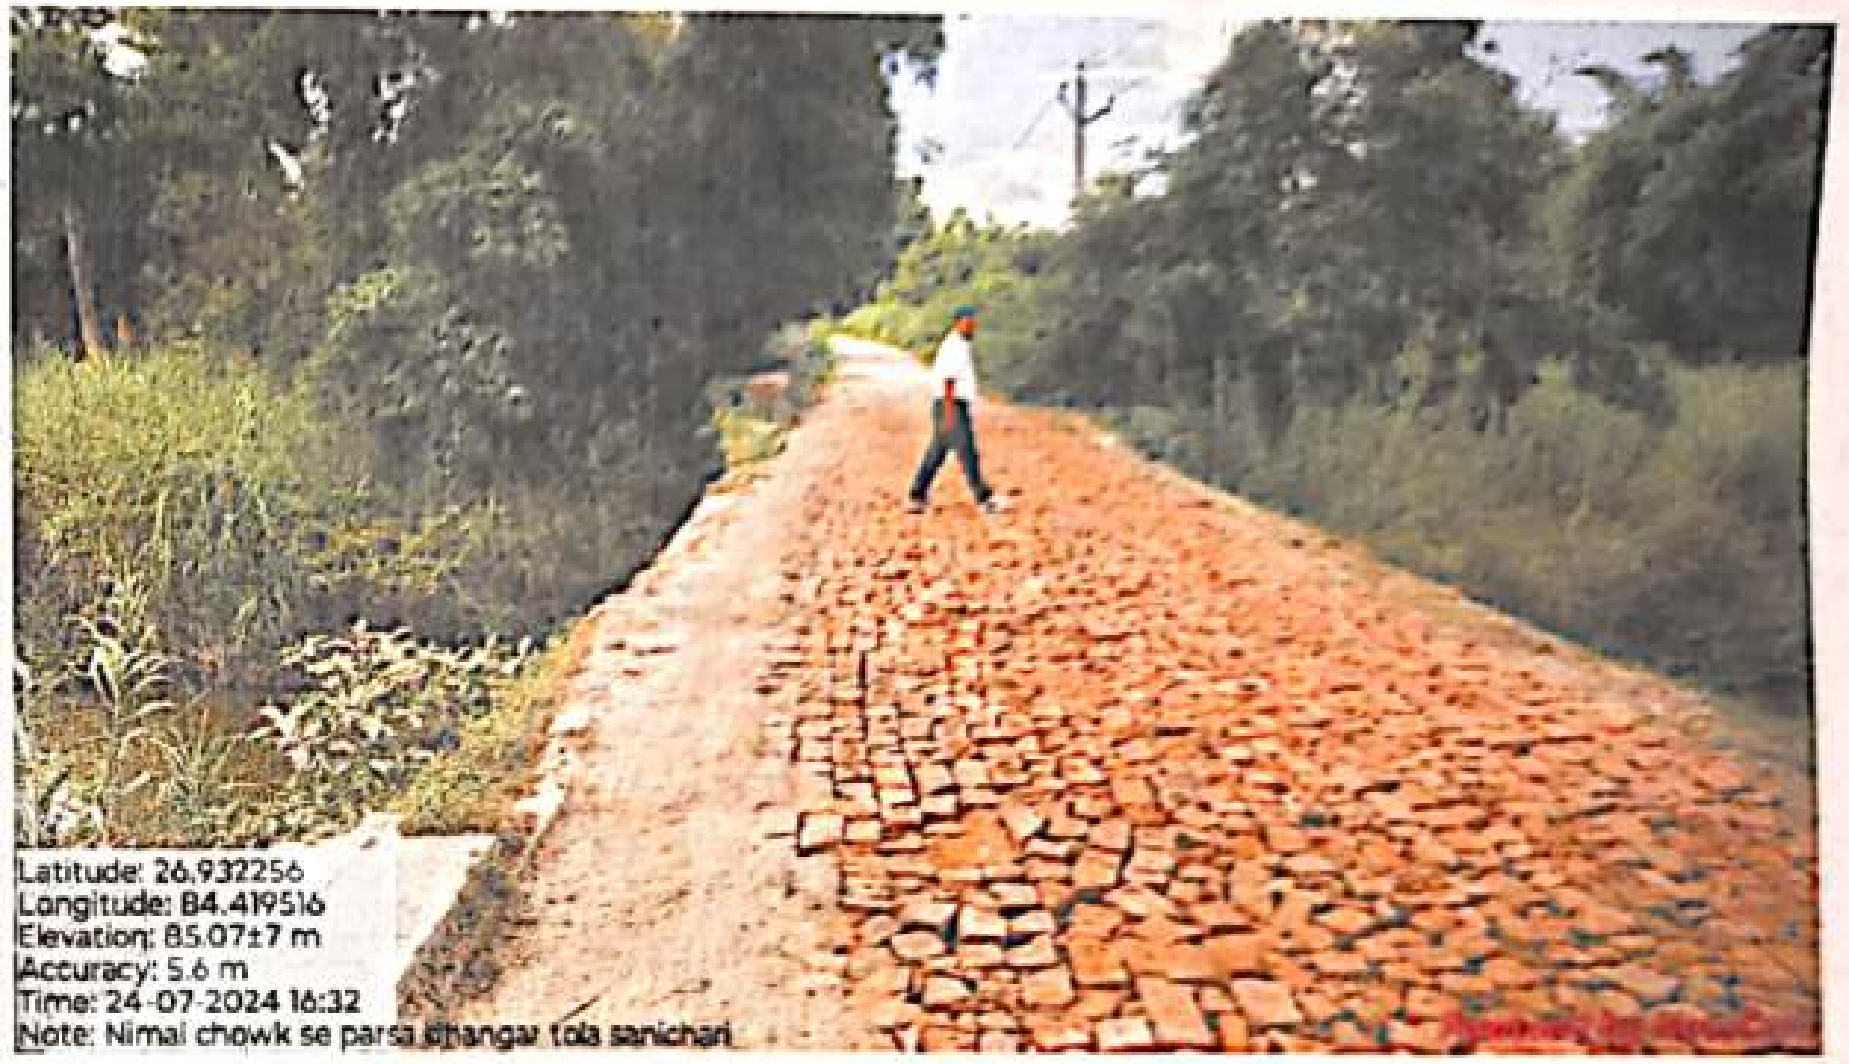
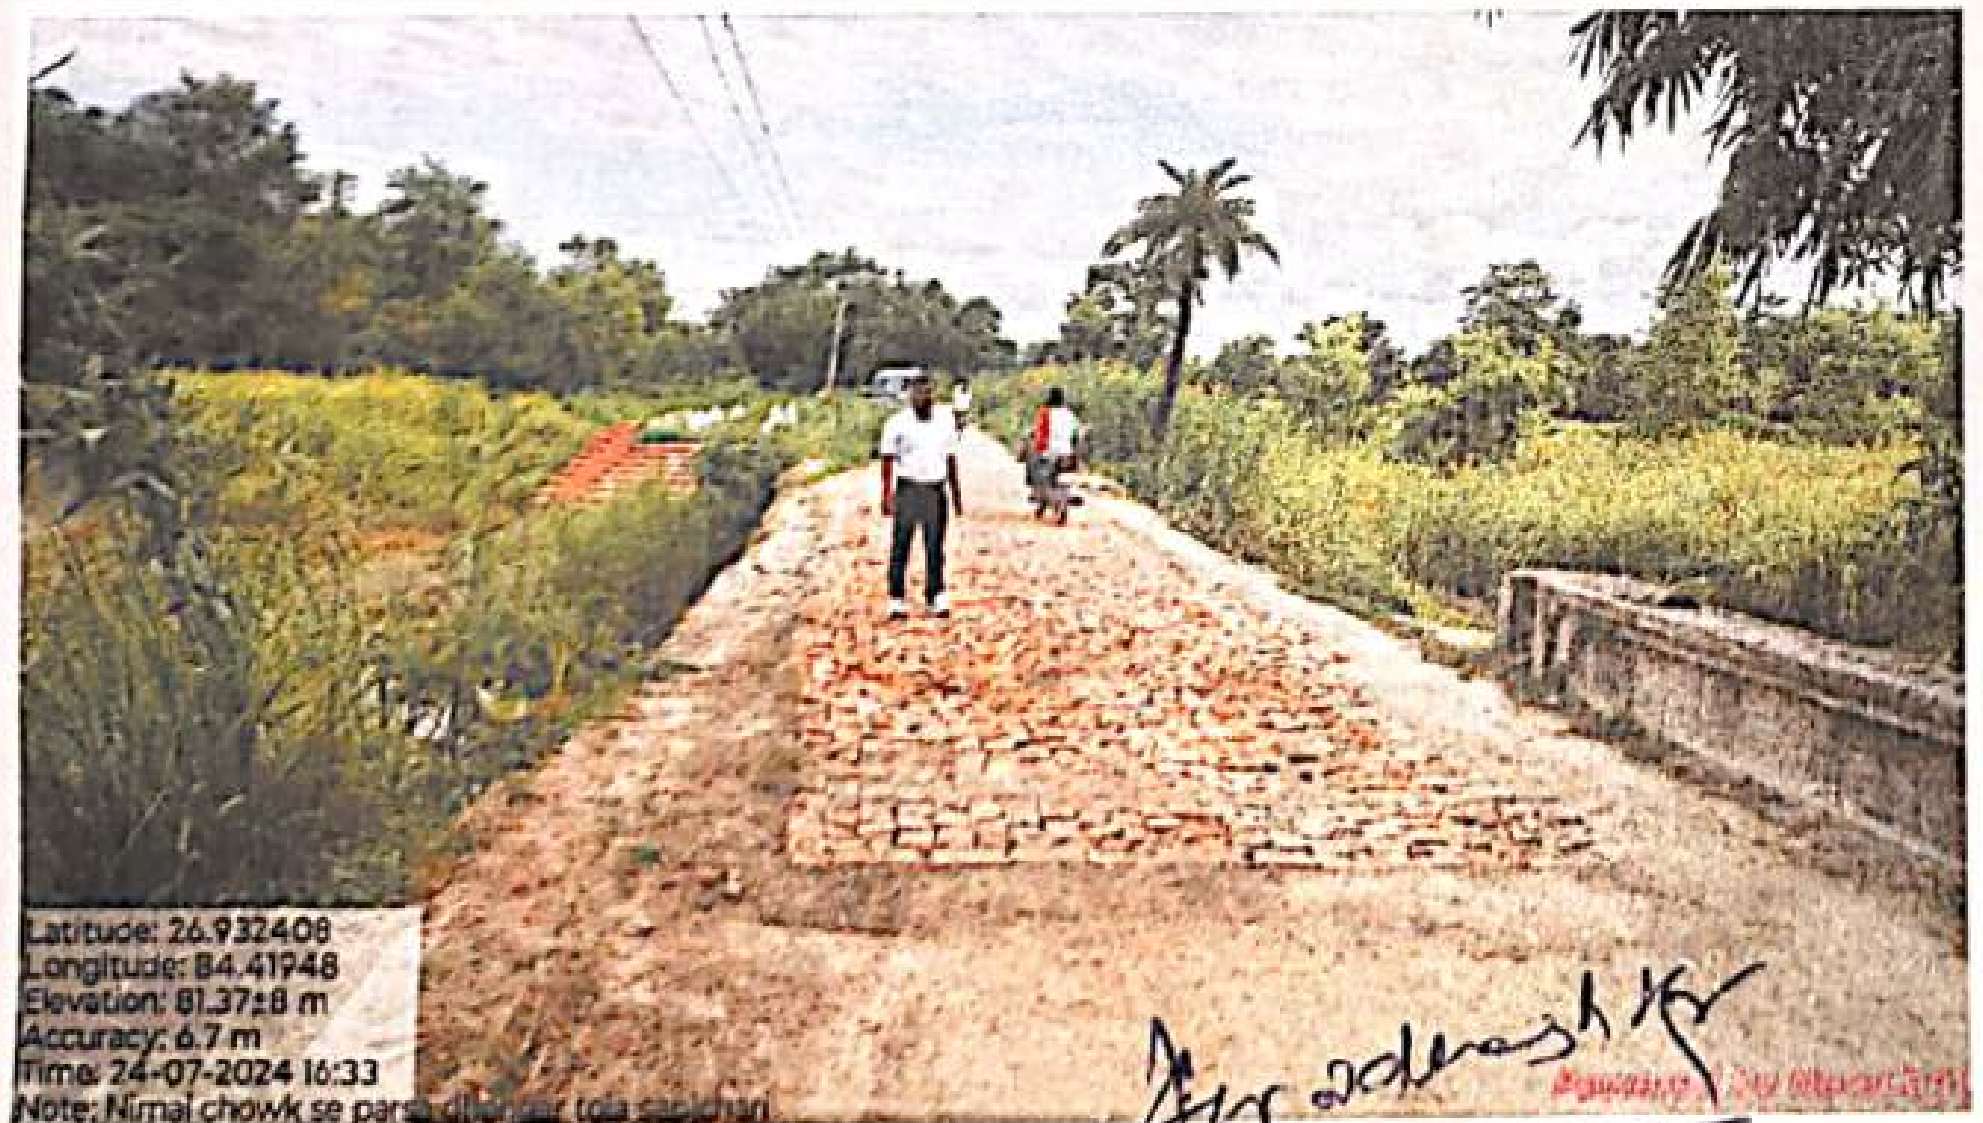
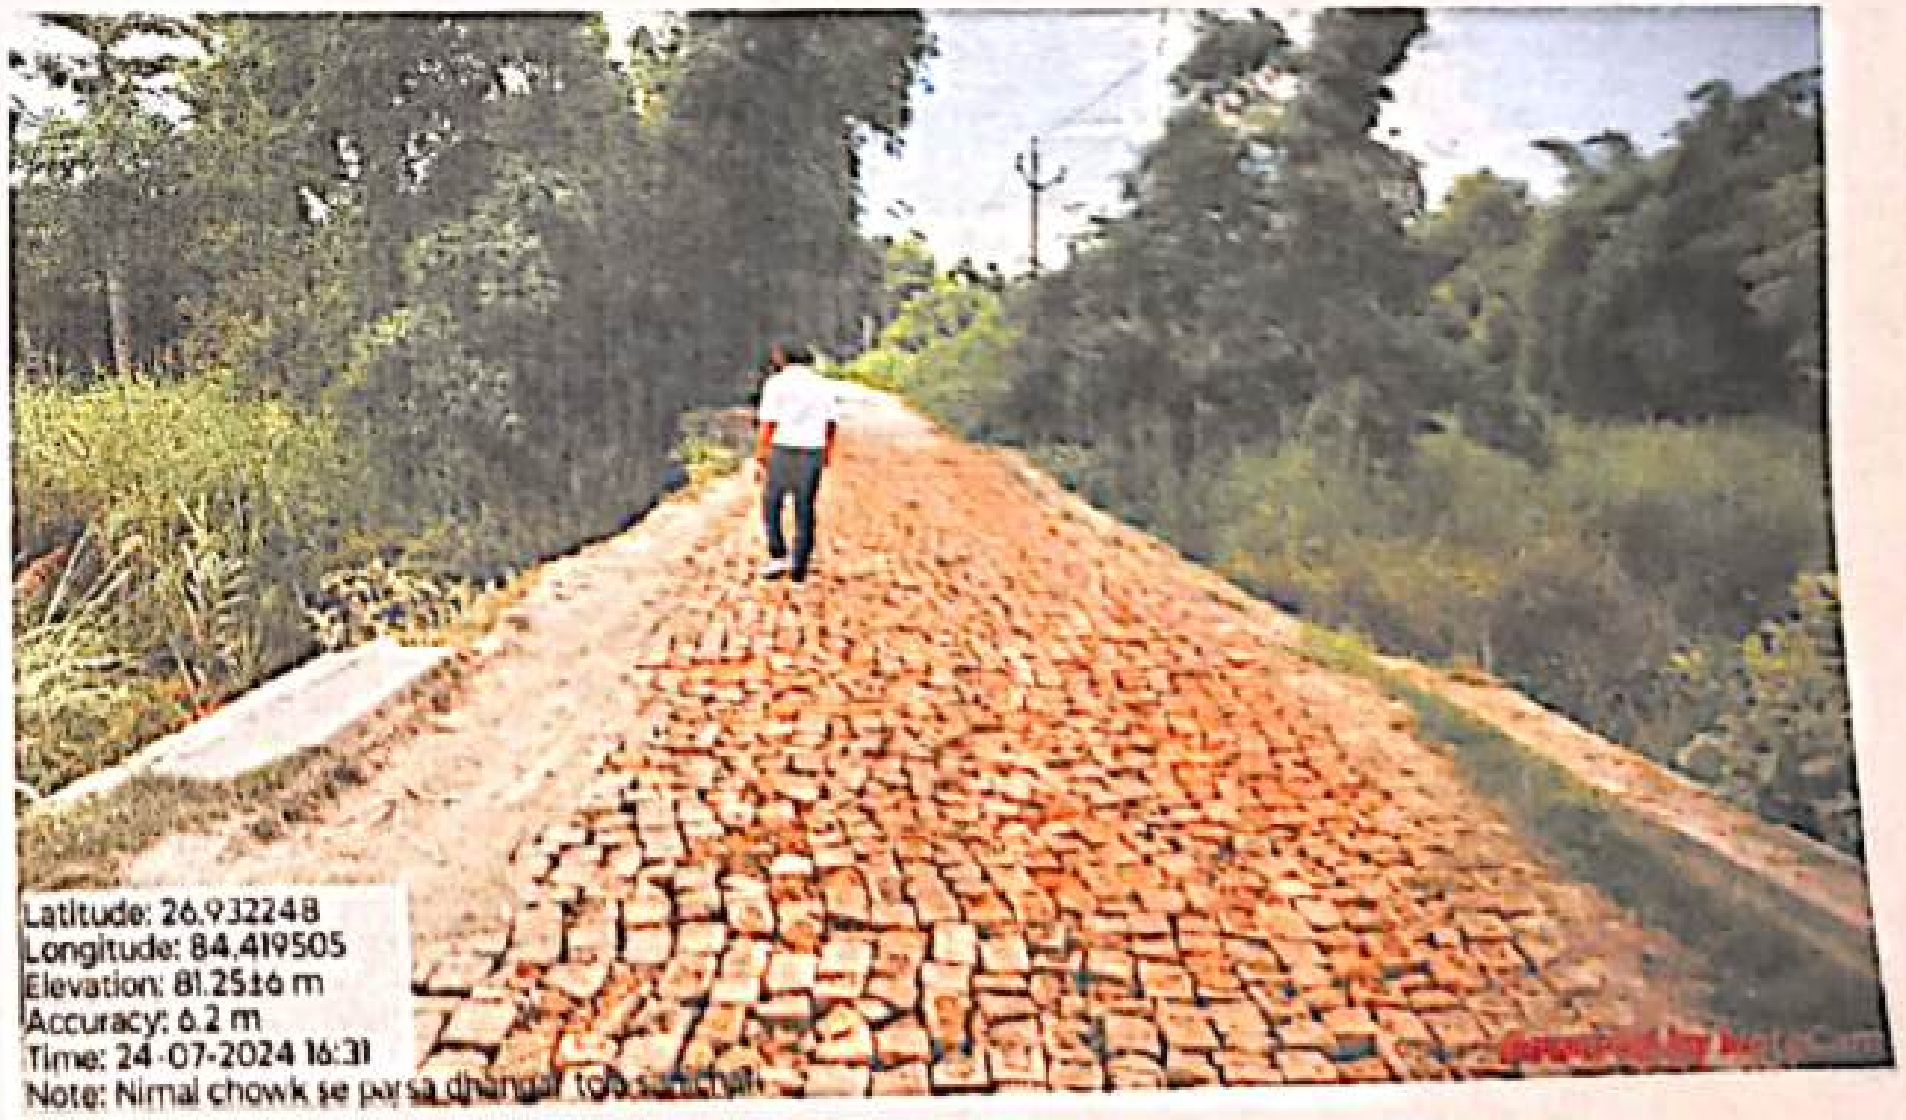
Name of Road - Nimai chowk se parsa dhangar toli sanichari -

1. Damaged Location/Chainage:- 670 – 710 m
2. Damage Length:- 0.025

3. Nature of Damage (Length	(i) Breach:-	
	(ii)Crust Damage:-	27.90m
	(iii) Only Flank Damage:-

Whether traffic fully/Partially obstructed:- Partially.

(i) Material Being Used in Restoration :- Brick Bats, Soil

(iii) Restored Length	(i) In open area :-	35m
	(ii) In habitation Area :-
